# MORPHOLOGICAL CHANGES OF THE DANUBE RIVER EAST OF VIENNA OVER THE LAST NINE YEARS

Tim Fischer-Antze, Dieter Gutknecht

*Vienna University of Technology, Institute of Hydraulics, Hydrology and Water Resources Management, Vienna, Austria, e-mail: fischer@hydro.tuwien.ac.at*

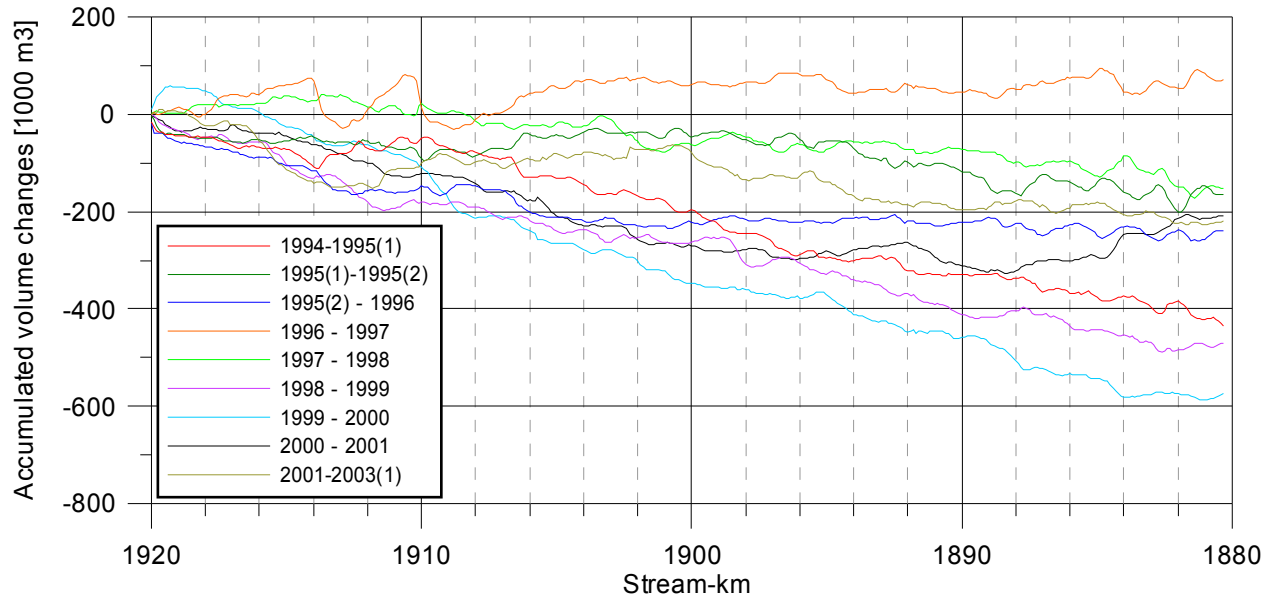
The results of the analysis of the measured bed levels show how the Danube river reach has changed over the study period of nine years. A profile averaged analysis of the bed volume changes is provided by analysing the accumulated bed changes. The accumulated bed changes for all consecutive bed surveys are depicted in figure 1. The trend of a successive bed erosion

is evident from the figure. The negative gradients, which occur for most of the periods indicate that most of the study reach is exposed to continuous erosion processes. The total erosion volumes range from 150,000 to 600,000 m<sup>3</sup> per period. An exception is the period 1996-1997 where apparently depositions took place. This period is discussed later in this paper in more detail.

Figure 1: Accumulated volume changes of the Danube river between Vienna (km 1920) and the Austrian-Slovakian border (km 1880).

The analysed mean bed changes for the entire 40 km reach vary within quite a wide range. In most of the periods, erosion occurred (see figure 1). The sediment dumpings were not sufficient to solve the erosion problem for the entire reach. Assuming a negligible amount of sediments passing the weir at the power station, the total computed bed changes can be correlated to the hydrology for the same period. Note that the sediment dumpings for this analysis were accounted for in calculating the total bed changes resulting in bed changes that would have naturally occurred during the periods. Including the dumpings results in negative bed changes (=erosions) for all the periods, also in the period 1996-1997 that results in an accumulation period when comparing the bed levels only (see figure 1). An automatic stream gauge is located at stream-km 1895. Water stage and discharge data were recorded at 15 minutes intervals starting from 1996.

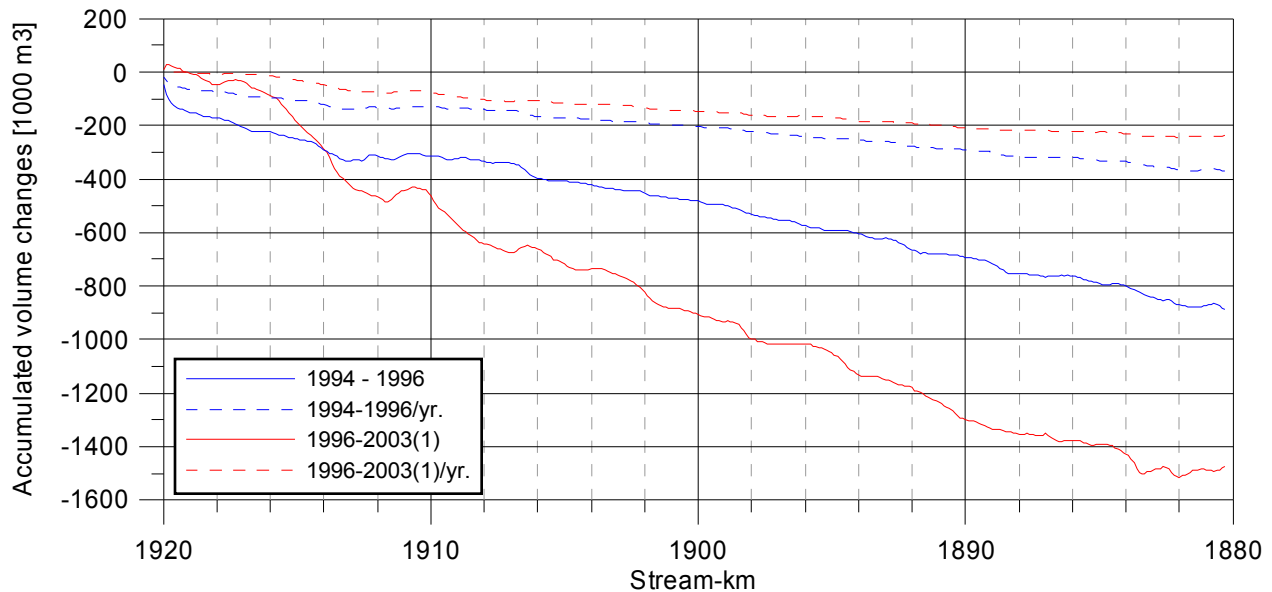
The entire observation period was divided into two sub-periods, 1994 to 1996 and 1996 to 2003. 1996 was the year when the hydropower station was constructed and the sediment dumpings started. Figure 2 shows the accumulated volume changes of these periods. The sediment dumpings of the operator of the power station obviously showed an effect since the negative bed changes per year became less obvious after 1996. The figure shows small bed changes in the most upstream 4 km reach from stream km 1920 to 1916. The chosen processing method indicates that downstream of km 1916 erosion processes occurred. The bed volume changes in this period add up to 1.5 million m<sup>3</sup>. Given the length of 40 km and assuming a mean measured channel width of approximately 250 m, results in a mean bed erosion of 15 cm. The time between 1996 and 2003 surveys was approximately 6.4 years giving a mean erosion rate of 2.3 cm per year.

Figure 2: Accumulated volume changes 1994-1996 and 1996-2003.

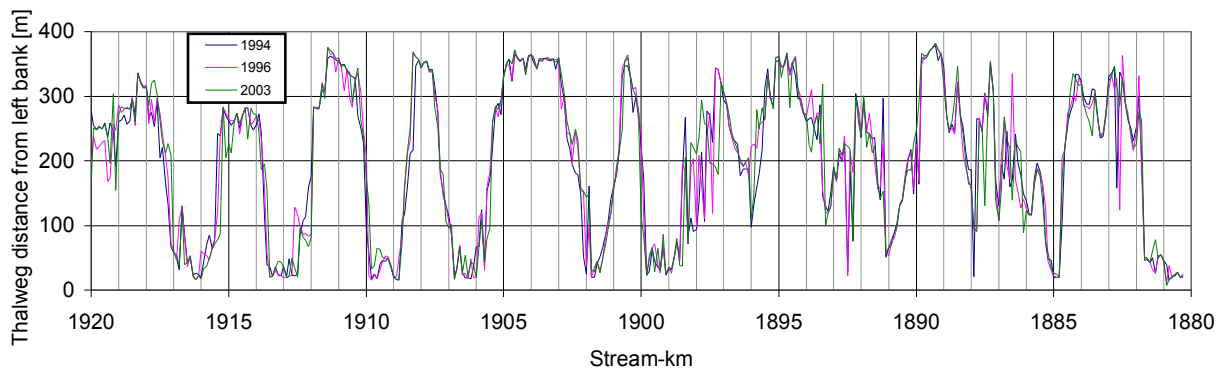
The significant bed changes found by the volume comparisons raise the question, how the more detailed morphology of the river bed has changed. Figure 3 shows the position of the thalweg for the years 1994, 1996 and 2003. The thalweg only changed slightly in the first 20 km. In this reach, an alternate bar configuration is apparent. The bars are partly secured by river engineering measures, groynes and spur dikes, so that bar propagation is prevented. The flow is forced into a predetermined channel, therefore only minor structural changes occur. The downstream half of the study reach shows stronger structural variations. In this reach, the alternate bar structures are not apparent anymore. Groynes were constructed in this reach over the entire study period. The main structures remain unchanged although some reaches show cross-sectional changes.

Figure 3: Thalweg position 1994, 1996 and 2003.

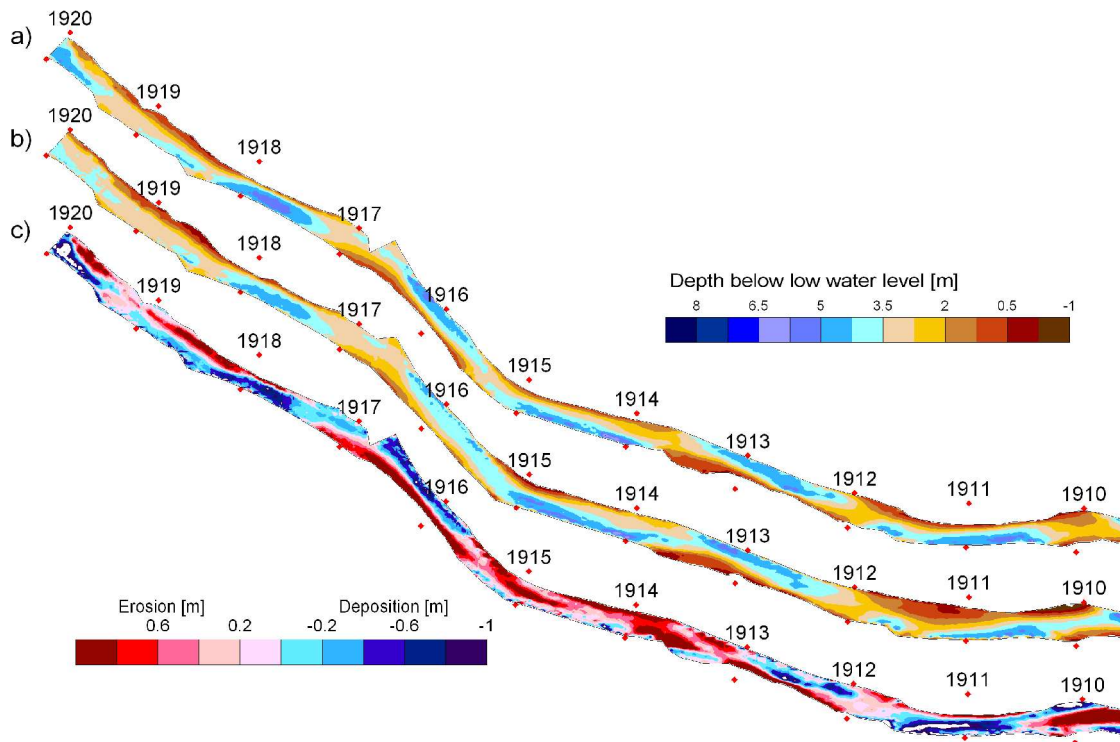
In figures 4 and 5, the water depths below a constant fixed low water surface for the years 1996 and 2003 are shown for parts of the reach. These are indicators of the bed levels. The bed changes obtained by subtracting the 2003 water depths from those of 1996 are

shown. Please note that bed topography information is not available for the full profile width, since the measuring boat was not able to obtain data in the shallow water regions. As indicated previously by the thalweg position, the reach shown in figures 4 and 5 is dominated by alternate bar structures with a length of approximately 3 km. Pool and shallow sequences alternate with a distinct periodicity. For navigation purposes, special attention needs to be given to the shallows which can be found here at the mean stream kms 1917.2, 1915.3, 1913.8, 1912.0, 1910.0, 1908.2, 1907.2, 1905.3 and 1902.0. Erosion areas can be found in most of these nine shallows. In the 7 year period, significant bed erosion occurred, especially in the shallows. The most significant bed changes were found there.

Figure 4: a) Water depths in 1996, b) water depths in 2003 and c) bed changes from 1996 to 2003 from stream-km 1920 to 1910.

The alternate bar structures are located in the regions between the shallows. Another morphological process can be found here. Bar regions tend to be exposed to erosion processes while the associated pool regions tend to be filled by bed material. These erosion and deposition patterns are present in seven out of ten bars. This process results in bar profiles that tend towards a uniform distribution, i.e., the profile develops towards a compact shape.

Both processes, the erosion of the shallows and the compact bar profiles decrease structural diversity. The erosion in the shallows are likely not only a result of natural morphodynamic processes. Regular river training works include the dredging of shallow river reaches. Strong dredging activities took place at two shallows at stream km 1913.8 and 1902.0. Here, strong bed changes are apparent which indicate that the dredging measures showed an effect. Figure 2 also suggests a stronger variation in local bed changes in the upstream 20 km compared to the downstream reach where the morphological structures are less pronounced.

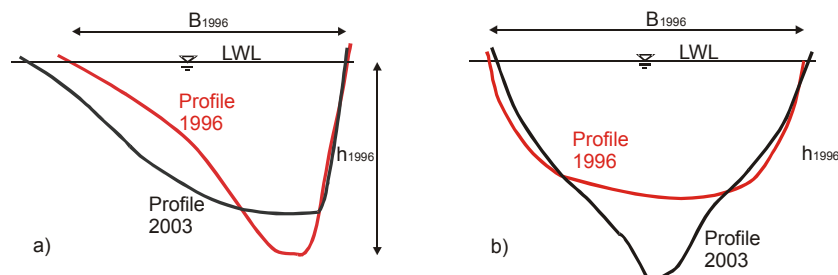
The processing of the erosion/deposition patterns is quite involved, the areas of the overlapping measurements and the grids for the surveys have to be computed and the results have to be examined visually. For this study, the question arose, if it was possible to find a simple parameter representing the processes mentioned above. For clarity, figure 6 shows a schematic of the observed processes for both the bar and the shallow region. A shape parameter describing both the trend towards a compact shape for the bar profile and the erosion of the shallow profile was found to be the ratio  $s = B/h$ , where  $B$  is the profile width at a fixed low water level (LWL) and  $h$  is the water depth to the thalweg, i.e. the deepest point in the profile. An increase of  $s$  leads to a profile from 1996 to 2003 in figure 6a and a decrease leads to a profile from figure 1996 to 2003 in figure 6b.

Figure 6: Schematic of cross-sectional profiles in a bar region (a) and in a shallow region (b).

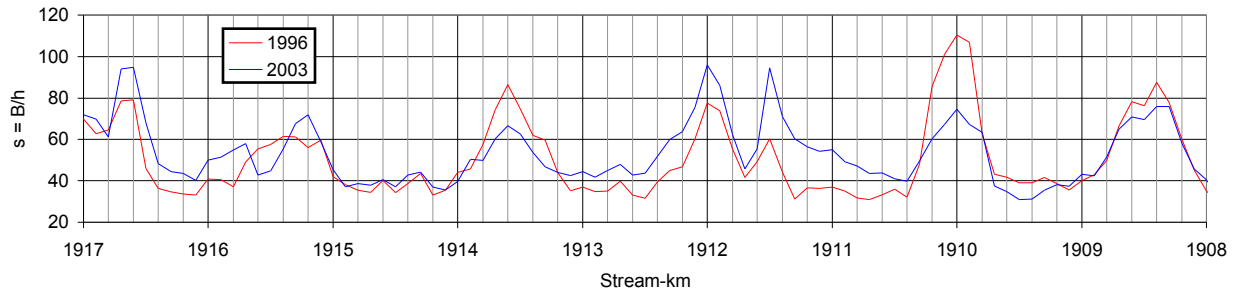
Figure 7 shows the result of the shape parameter  $s$  that was computed from stream-km 1917 to 1908, a reach with strong alternate bar configuration. The plot detects the development of typical bar and shallow regions when analysing the change of the parameter  $s$ . Reaches where the parameter increased over time ( $s_{2003} > s_{1996}$ ) represent bar regions with a trend towards a compact shape, whereas reaches with a decreasing parameter ( $s_{2003} < s_{1996}$ ) represent the shallow reaches. It can also be seen that the shallow at stream-km 1912.0 does not follow this trend. Here, the morphological change did not follow the mechanism shown in figure 6b. Unlike the other shallows, here, the bed change was affected by the downstream bar adjacent to this profile (see figure 4). Also, the bar downstream of km 1910 shows partly a different behaviour, since it is influenced by the erosion process of the upstream shallow. The aforementioned bar process is found further downstream of this bar.

Figure 7: Shape parameter  $s$ .
