# EFFECT OF EROSION CONTROL WORKS ON SOIL EROSION AND SEDIMENT TRANSPORT IN THE ALDINAČKA REKA WATERSHED

Stanimir Kostadinov and Igor Stajić

*Faculty of Forestry, Belgrade University, Belgrade, Serbia and Montenegro,  
e-mail: kost@EUnet.yu*

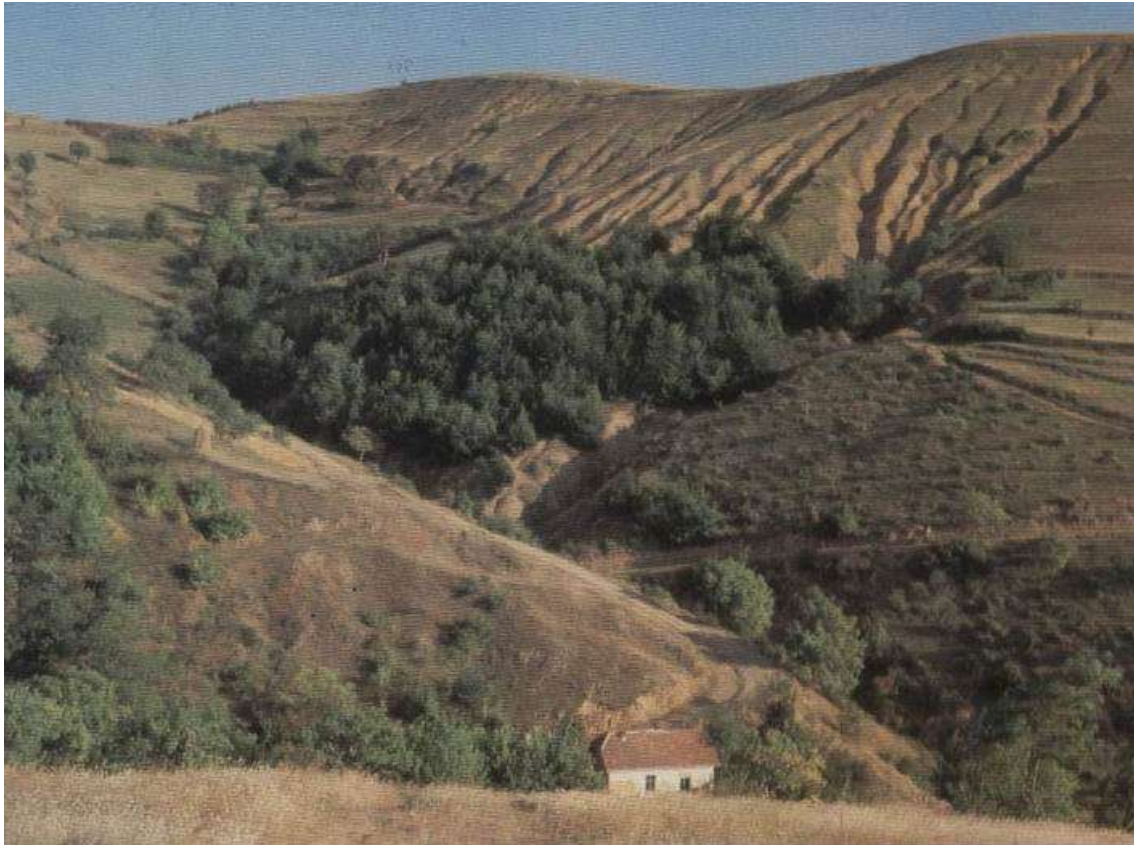
Figure 3. Sheet and gully erosion in the upper part of the watershed, before ECWs

Owing to the natural conditions of relief, parent rocks, soil types, land use and particularly due to inadequate soil management, intensive erosion dominated in the watershed. Soil erosion of different intensity attacked practically all parts of the Aldinačka Reka watershed before the erosion control works. The most widespread form was sheet erosion, or runoff erosion. Excessive erosion processes occurred mainly in the upper parts of the watershed and on the south exposures. Along with runoff, almost a half of the watershed was attacked by a dense network of gullies up to 10 m deep. The Aldinačka Reka watershed was a typical example of how very intensive erosion processes occur after the destruction of the vegetation cover.

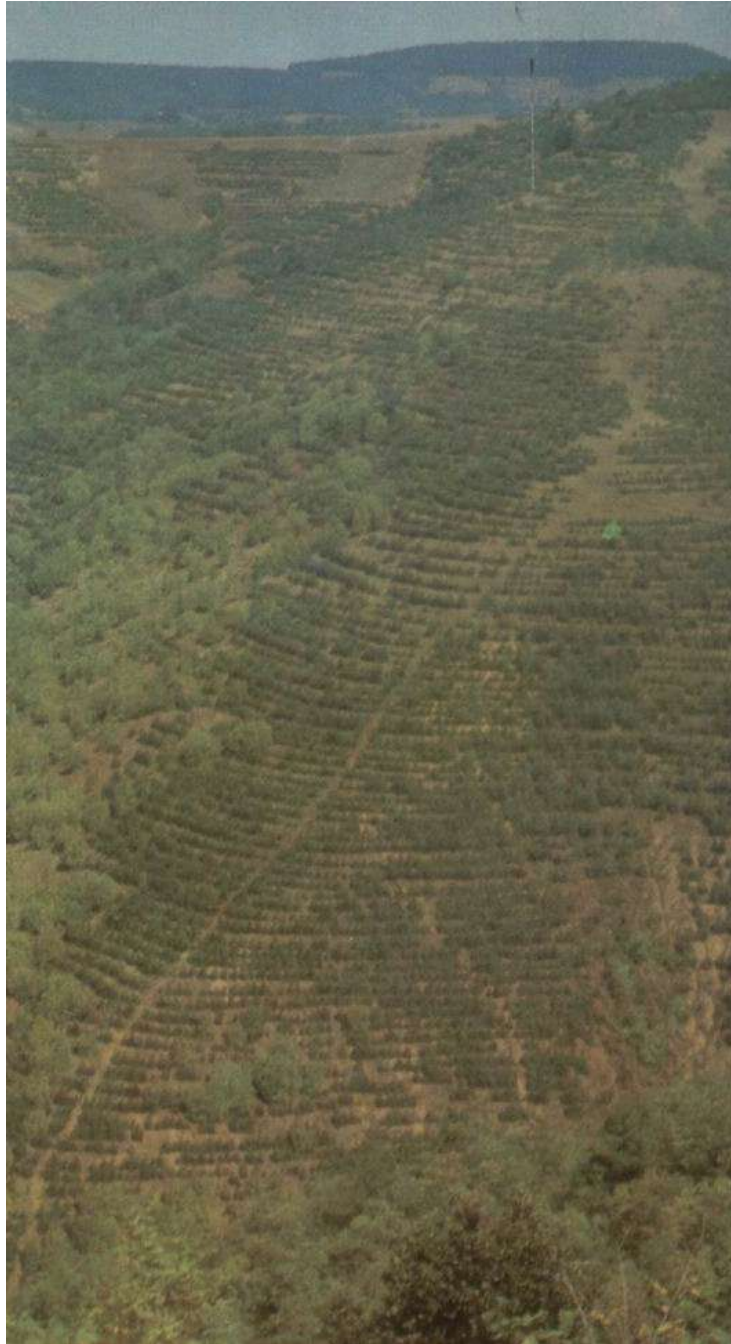
Figure 3. Afforestation of steep slope using the gradons

As the channel of the recipient and the main tributaries was cut into the bedrock, erosion control works were mainly directed to the works in the watershed: afforestation by various methods and grassing of the terrains endangered by erosion. As the steep slopes of the watershed were severely eroded, afforestation and grassing would not have succeeded without previous retention works (gradons, terraces, wattling, horizontal walls, etc.). These works provided a stable support to the development of the planted seedlings of Austrian pine, Scots pine, spruce and black locust, which were mainly applied in afforestation. Along with the above works, local population established orchards spontaneously on steep slopes on the former farmland.
